**PUBLIC  
PAPER**

Issue: 0902

**SEISMIC RESISTANT  
SCHOOLS FOR SICHUAN**

Dr Derry Yu, Senior Engineer, Hyder Consulting

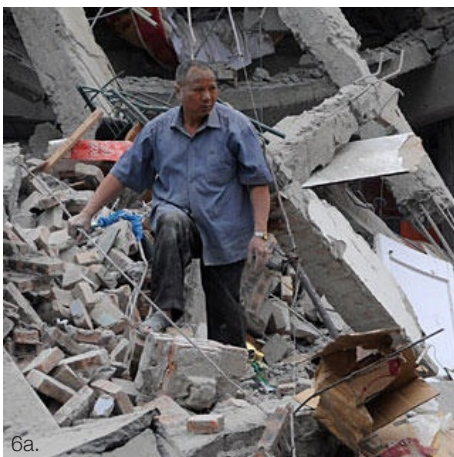
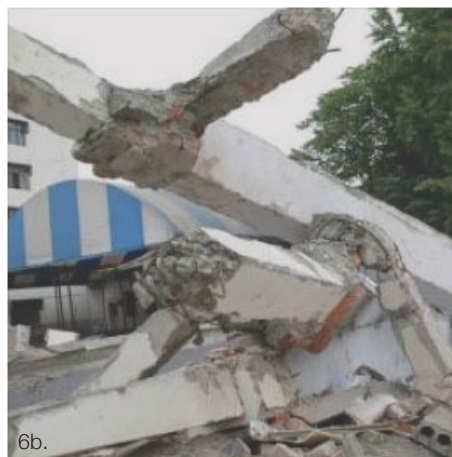
Figure 6 a & b. Collapse of apartment in 512 Sichuan Earthquake [10]

Figure 6 shows a reinforced concrete frame structure with a brittle failure caused by poor construction quality, improper structural design and detailing. An unconfined masonry wall has collapsed in the left photo. In the right photo, a precast RC slab has collapsed due to poor connections between precast slab and RC beams.

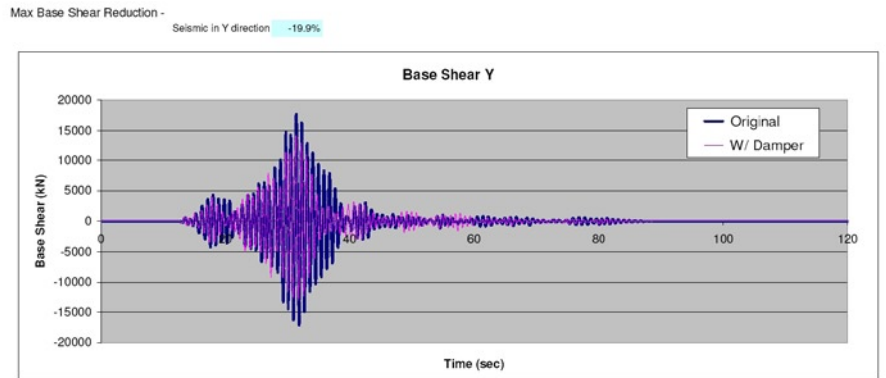
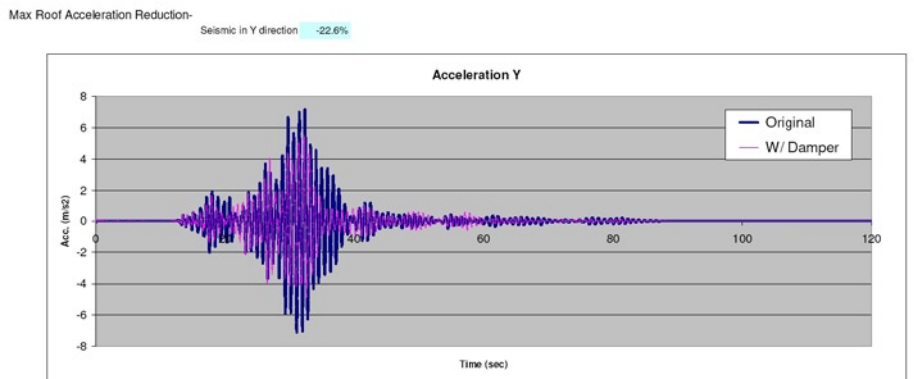
Figure 10. Responses of both Type B and Type C buildings

1. As shown in Figure 10, it can be seen that the total base shear for Type C building in the short span is 18% less than a Type B building. It means design seismic loading can be reduced for a Type C building and it will result in the deduction of structural members.
2. The maximum roof acceleration for a Type C building in the short span is 22.6% less than a Type B building as shown in the middle of Figure 10.
3. The maximum roof displacement for a Type C building in short span is 31% less than a Type B building as shown in the bottom of Figure 10.
4. As shown in Figure 11, it can be seen that 32% of the total input energy of earthquake has been absorbed by the damping panels, it means the energy transferred to the structural members of Type C is only 68% of Type B.

For a Type C building, the cost of the damping panel is about CNY21,000/unit, so the total of 20 units is CNY420,000 which is about 10% of the total cost for a super structure. As stated before, the base shear for Type C building is 18% less than Type B, meaning the dimensions of main structural members of Type C could be reduced while keeping the same seismic capacity as a Type B building.
